Subject: Report of Current Activities

SELFUSO PREPARED BY	PASADENA	HYCON MFG. COMPANY	CALIFORNIA	PAGE 1 of 4
CHECKED BY <i>AB</i>	DURABILITY TEST HS-732			FOR HS-732
DATE 29 Oct 57	Serial #62			REPORT

PREPARED BY <u>DMT</u>	PASADENA	HYCON MFG. COMPANY	CALIFORNIA	PAGE _____
CHECKED BY _____	PRELIMINARY ENGINEERING REPORT, VIBRATION STUDY 73-B SHUTTER			JOB _____
DATE <u>11-12-57</u>				REPORT _____

PREPARED BY <u>DMT</u>	PASADENA	HYCON MFG. COMPANY	CALIFORNIA	PAGE _____
CHECKED BY _____	VIBRATION DATA CONFIG. 73-B			JOB _____
DATE <u>11-12-57</u>				REPORT _____

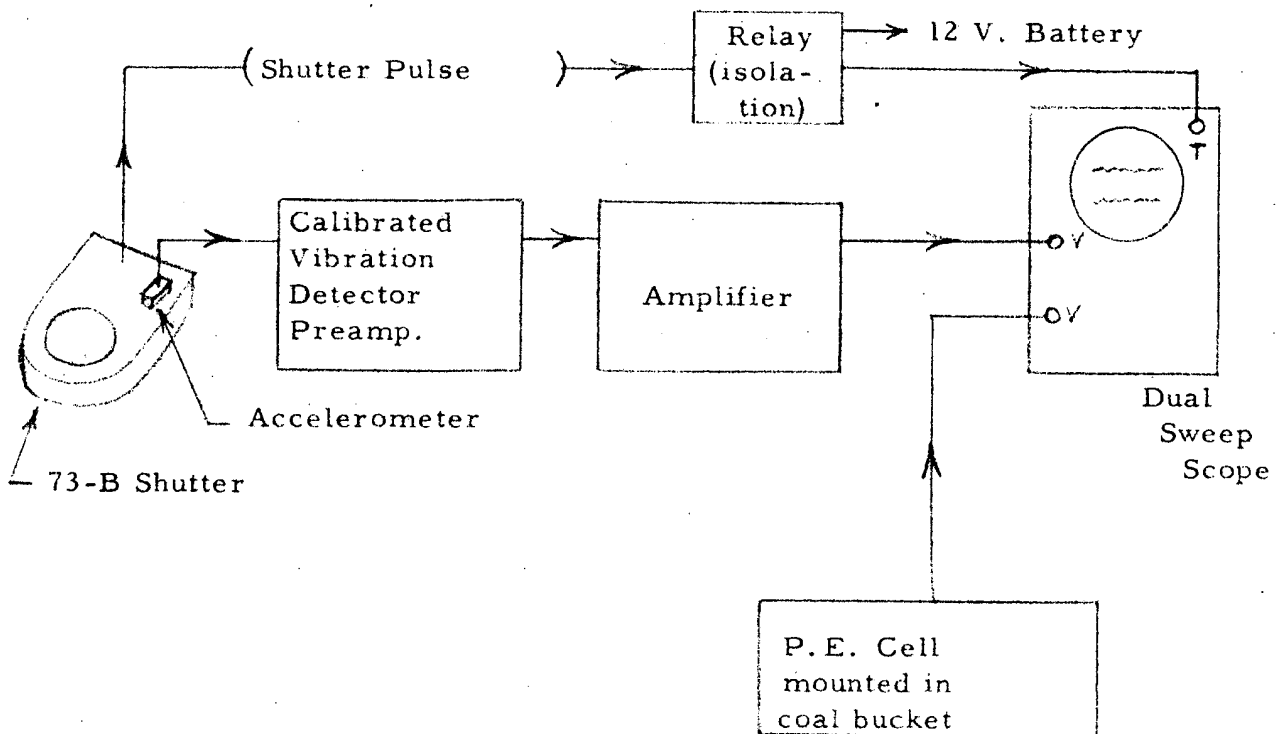
1. Tests were conducted on 10-21-57 by Moors and Cadman.
2. Test Conditions: 73-B Shutter Serial #37 was mounted in B Configuration, Serial #2. The configuration was secured to the ridged steel mount on a concret floor. Ambient noise levels were low enough to be acceptable during the test period.
3. The output from the accelerometer was fed into the calibrated vibration detector where it was preamplified, then to the amplifier. This output was connected to the vertical input on one channel of a double sweep scope. The photo electric cell was placed in the "coal bucket" inside the configuration, the output being connected to the second channel vertical input on the scope. The scope was triggered by a 12 volt battery source actuated thru a relay controlled by the shutter trip pulse.
4. Actual recordings were made with a Polaroid Recording Camera attached to the scope.
